EASTMAN

Injection molding
Troubleshooting guide

Eastman copolyesters

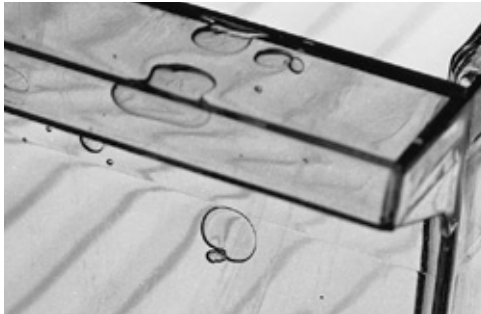
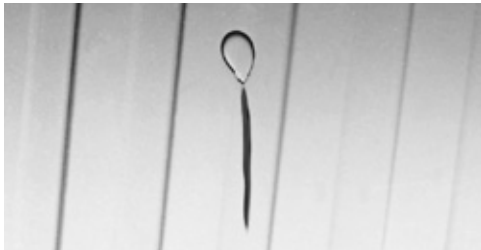
Air splay and decompression splay

Splay is defined here to include any defects that appear as smeared material or bubbles on the part surface, usually oriented in the flow direction. Appearance alone cannot tell you which type of splay is present. To decide on the likely cause(s), test each to prove/disprove whether it is causing the splay, then take the corrective action indicated.

Possible cause	Corrective action
Trapped air on screws	Decrease screw rpm. Increase back pressure. Check to ensure uniform recovery time; if not, decrease screw rpm or try reverse temperature profile. Review screw design with Eastman Technical Representative.
Trapped air in nozzle	Reduce decompression (suck back) or sprue break.
Trapped air in tool (foamy tail on bubbles)	Investigate (possibly using series of short shots) sources of air in tool such as weld line formation, inadequate venting, unusual shapes of pins where air remains after the flow passes, etc.
